A Few Words Regarding Utilities

Utility Design that Effects the Locating Signal

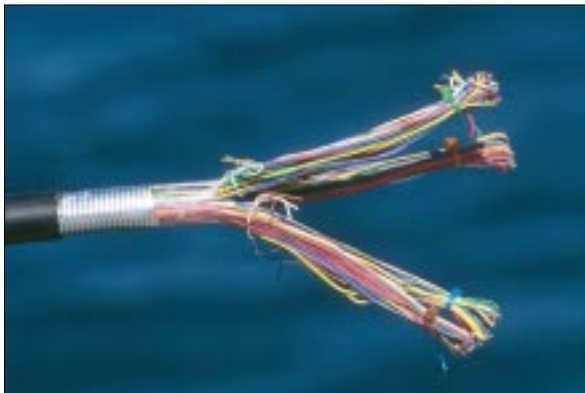
Telephone
Sheath

Utilities can be located because they generally consist of a continuous metallic conductor that can be accessed at above ground points. These conductors are shown in the following pictures:

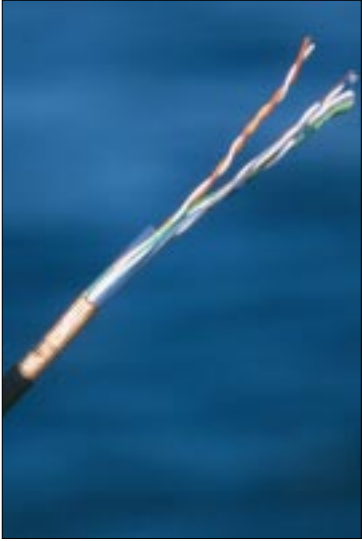
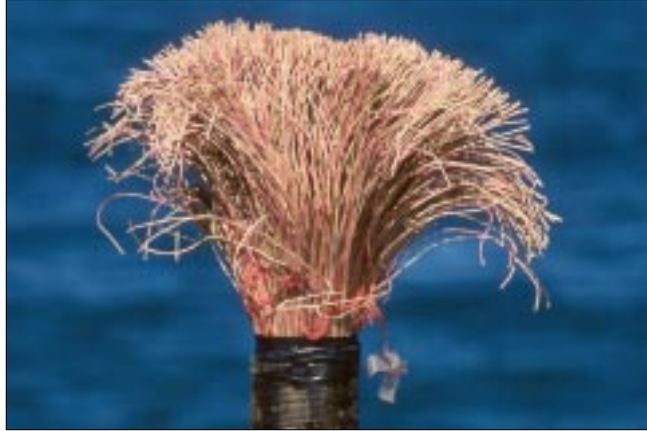
Telephone

5 pair drop---1800 pair toll cable

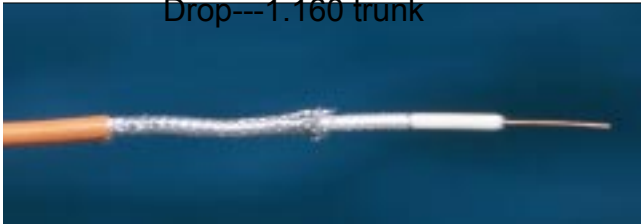
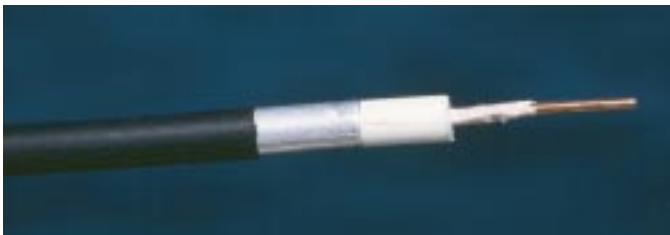
CATV

Drop---1.160 trunk

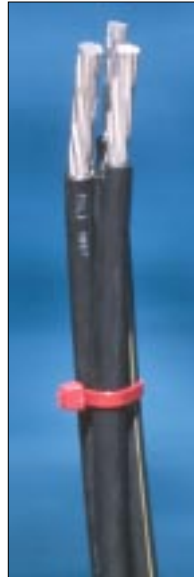
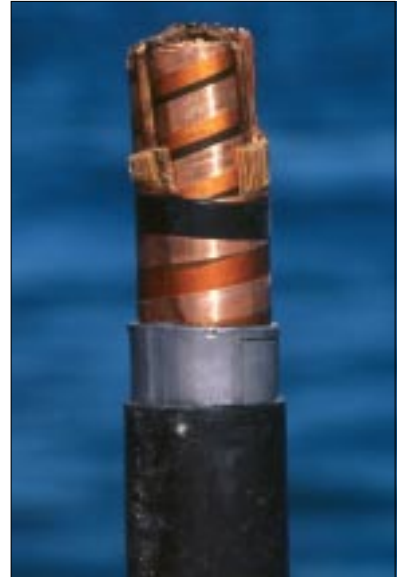
Electric

1/0 secondary---lead
network cable

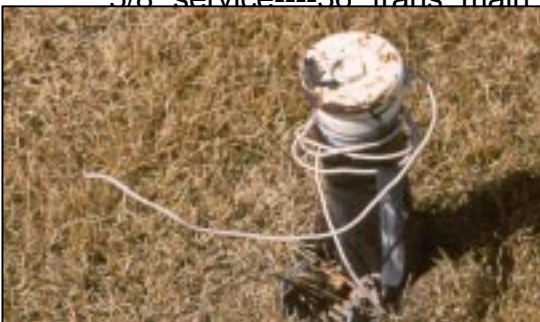
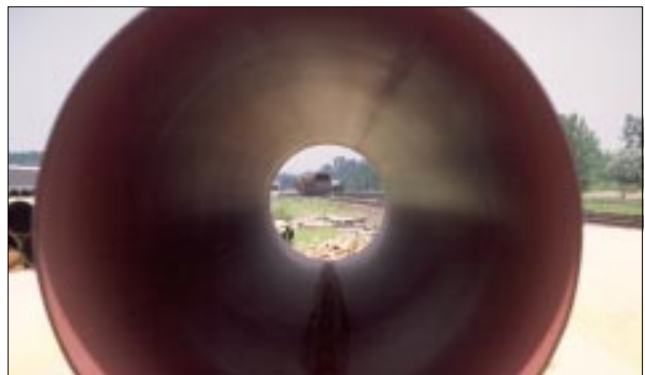
Gas

5/8" service---36" trans. main

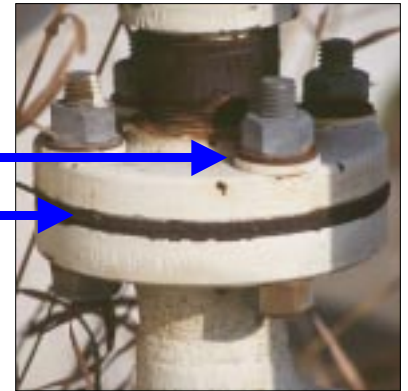
Insulated flange uses non-metallic components to separate metal bolts and flange halves.

Locating becomes difficult when there is a breach in the metallic continuity of the facility to be located.

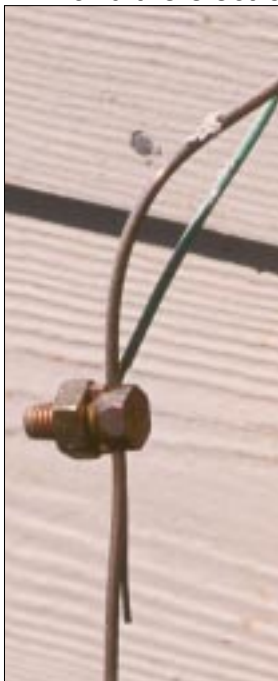
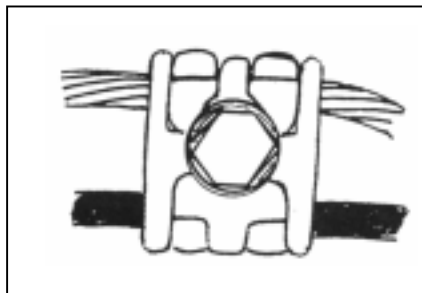
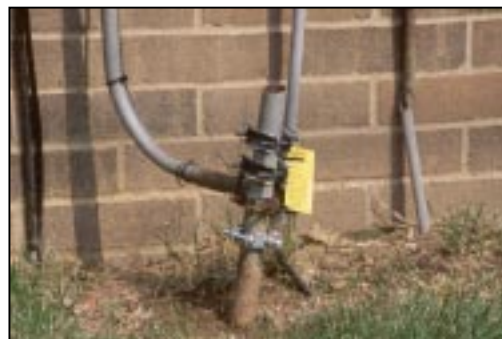
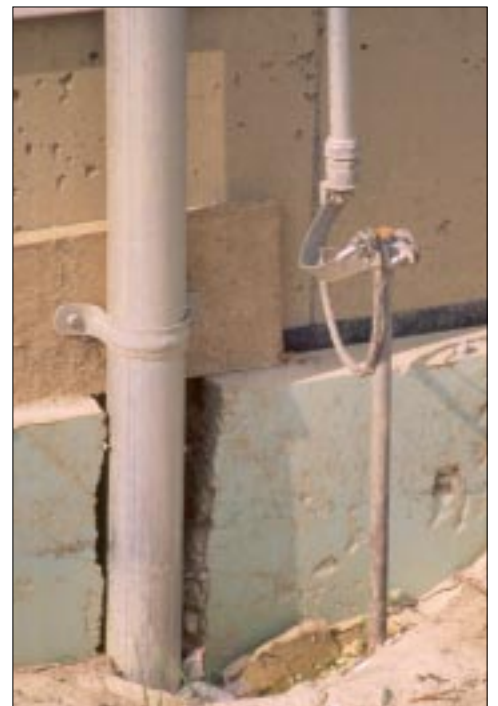
Common Grounding

Inadvertent energizing of a conductor can be caused by: 1) direct contact with energized wires, or 2) induction onto conductors located close to changing electric and magnetic fields created by high voltage lines or lightning. Lightning can induce high voltages into the utility system without a direct strike. Proper grounding and bonding will dissipate these voltages safely. Any inadvertent energizing of the utility system can be dangerous to personnel, the general public and the electronic equipment used in the utility system.
