DEEDS

A Substantial Amount of Work

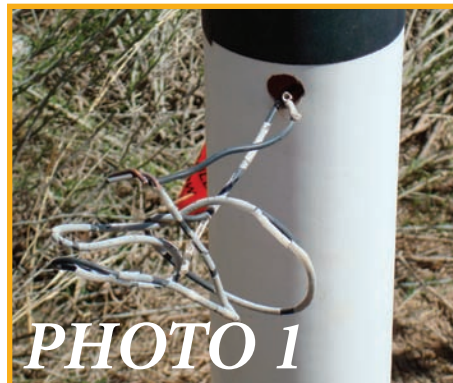
When the cell tower was built in 2001, most cell towers connected to their carriers' aggregation point via copper cables. But this tower was fed by fiber that traveled to its source along high voltage electric transmission towers. In order to reach the electric transmission system the fiber was installed in an underground conduit running along the boulevard. The fiber was a dielectric meaning that there was no metallic content in the cable. The conduit route was made locatable by the use of a tracer wire installed with the conduit. In order to be accessible by one-call personnel, the tracer wire was brought to the surface at marker posts situated along the route. The tracer wire was actually a series of wires. A wire began at one marker post and ended at another marker post. At each marker post, the two ends were stripped of insulation and twisted together (see photo #1).

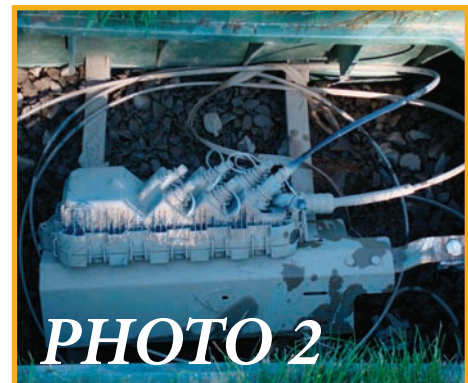
The replacement of the copper phone system with an all-new fiber system in 2008 created new challenges for locators entrusted to protect the new cables from excavation damage in 2010. The fiber drop cables were manufactured with a 24-gauge tracer wire inside the cable (see photo #2). The feeder cables were dielectric cables placed inside conduits manufactured either with aluminum sheaths (see photo #3) or with 22-gauge tracer wire embedded in the wall of the conduit (see photo #4). Due to a lack of far-end grounding as well as a lack of metallic continuity, those who performed one-calls for the phone company were in for a rude awakening.
